Denver Parks & Recreation – Recycled Water Management Advisory Committee Report

1.0 Background

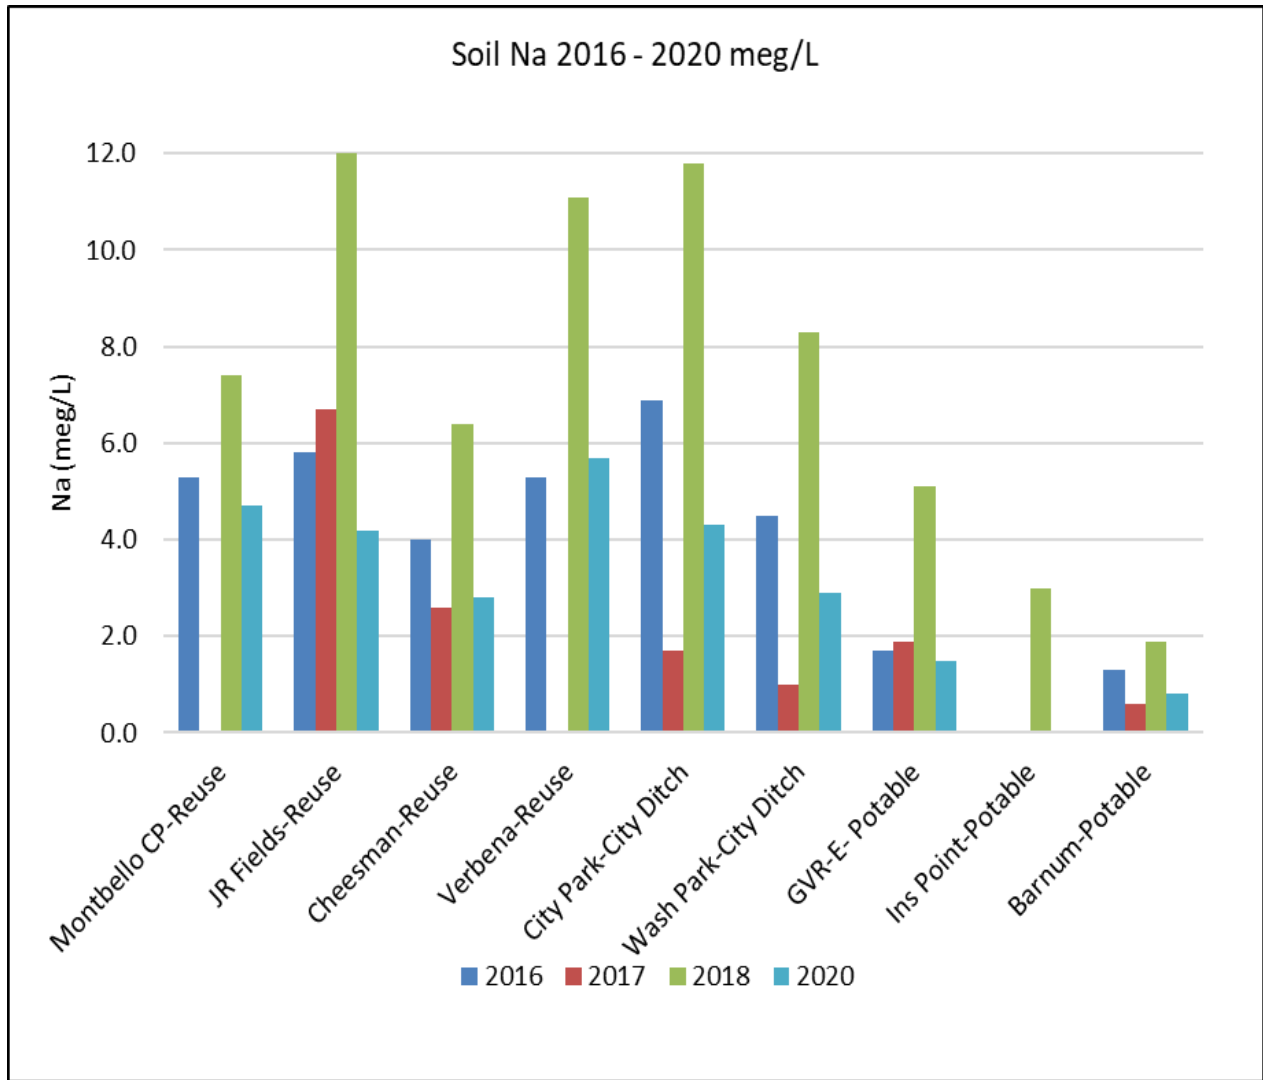
- Data for 2019 Na eliminated due to apparent testing/lab errors.
- Saline/sodic soil is more accurately indicated by EC, and SAR (see charts on next page).

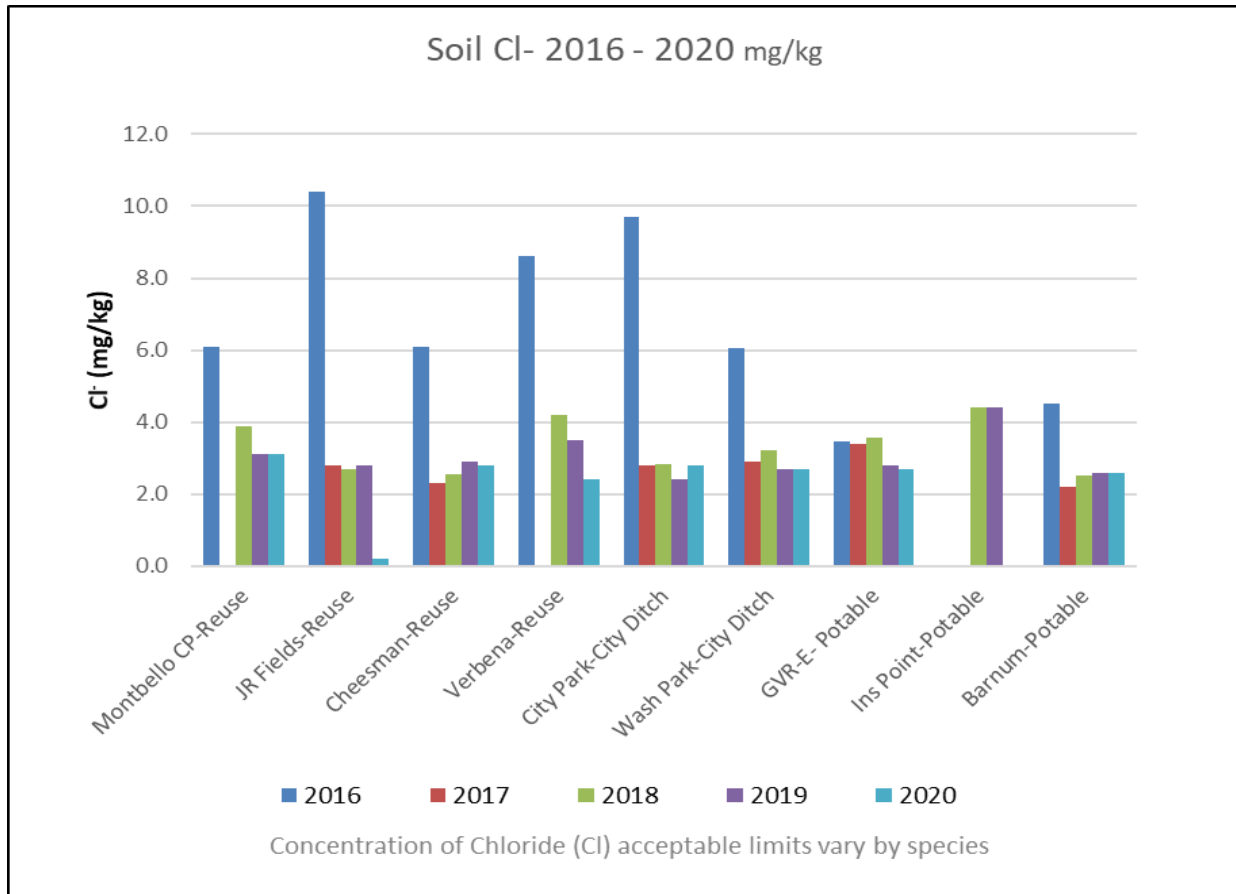
Chloride Levels above 8.00 mg/kg cause impaired root growth and become toxic at 13.00mg/kg
 2016 testing results appear to be inaccurate.

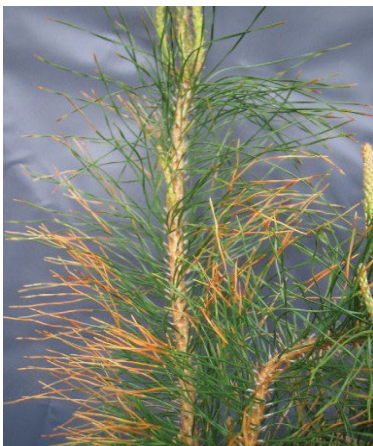
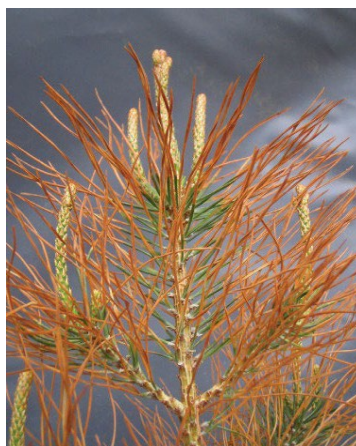
Tip burn on conifer foliage. Low severity of tip burn (left), High severity of tip burn (right).

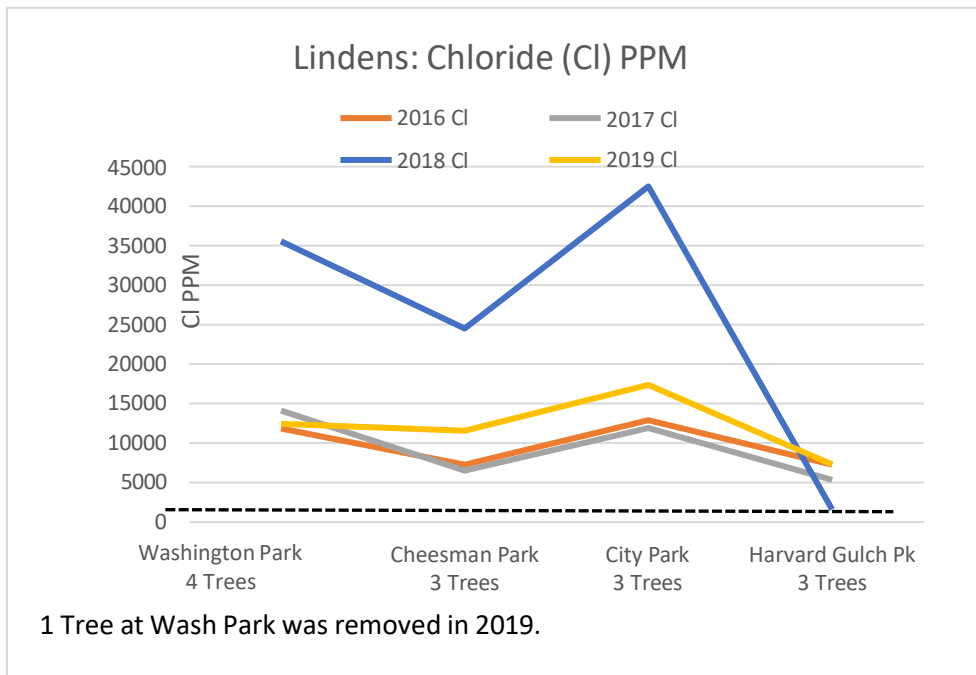
Chloride (Cl) is high if ≥ 1600 PPM
