DeBoer Park Bridge Closure FAQs

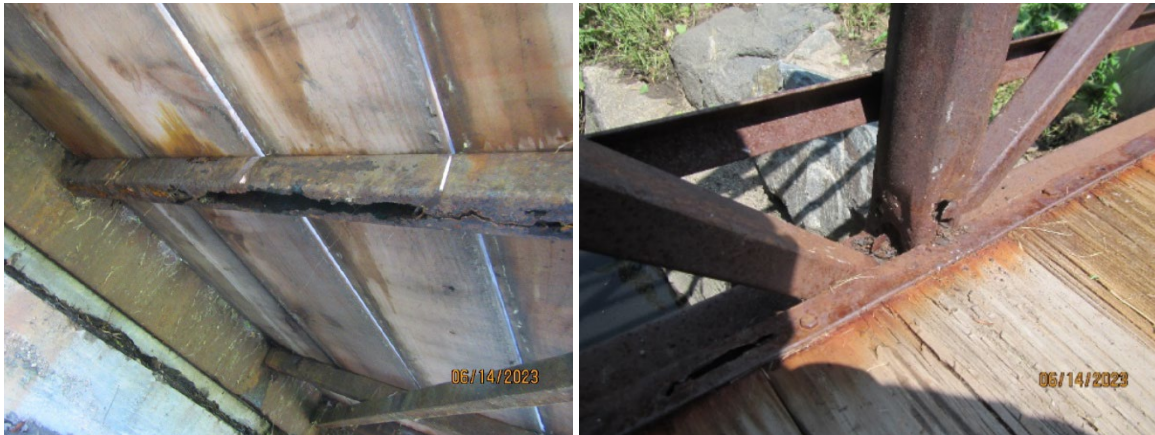
In June 2023, the bridge was found to have critical structural issues which could not be repaired and required a complete replacement of the bridge.

Photo on the right shows one of multiple vertical truss members with swelling and section loss from water getting trapped inside. Photo on left shows one of many locations where the stringers have rested-through holes up to 2 feet long.

The existing bridge does not meet modern standards and requires a new design, which has added to the project timeline. Currently under design, the new bridge must comply with all local, state, and federal requirements. Because it is located in the Harvard Gulch floodplain, construction must be completed within the low-flow season of October to April, meaning construction cannot begin any earlier than October 2025. Pending project funding, the new bridge is expected to be complete by Summer 2026.

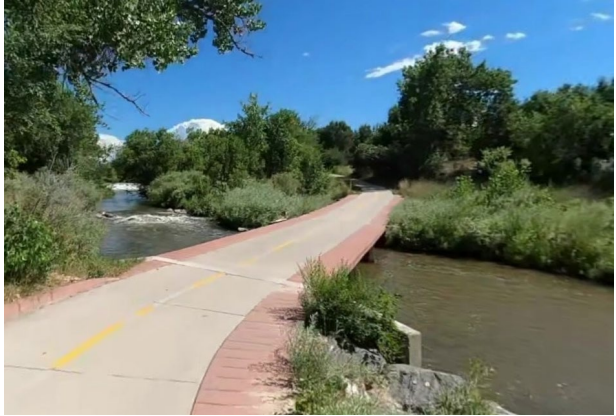
The new bridge will look a little different and will likely be a low-flow crossing. These structures are used widely along Cherry Creek such as the bridge pictured below near Holly Street.

Photo shows example low flow bridge structure.
